Investigation on Performance of Jia Bharali River Bank Protection Measure Using Geotextile Bags

Mayank Kumar Gupta

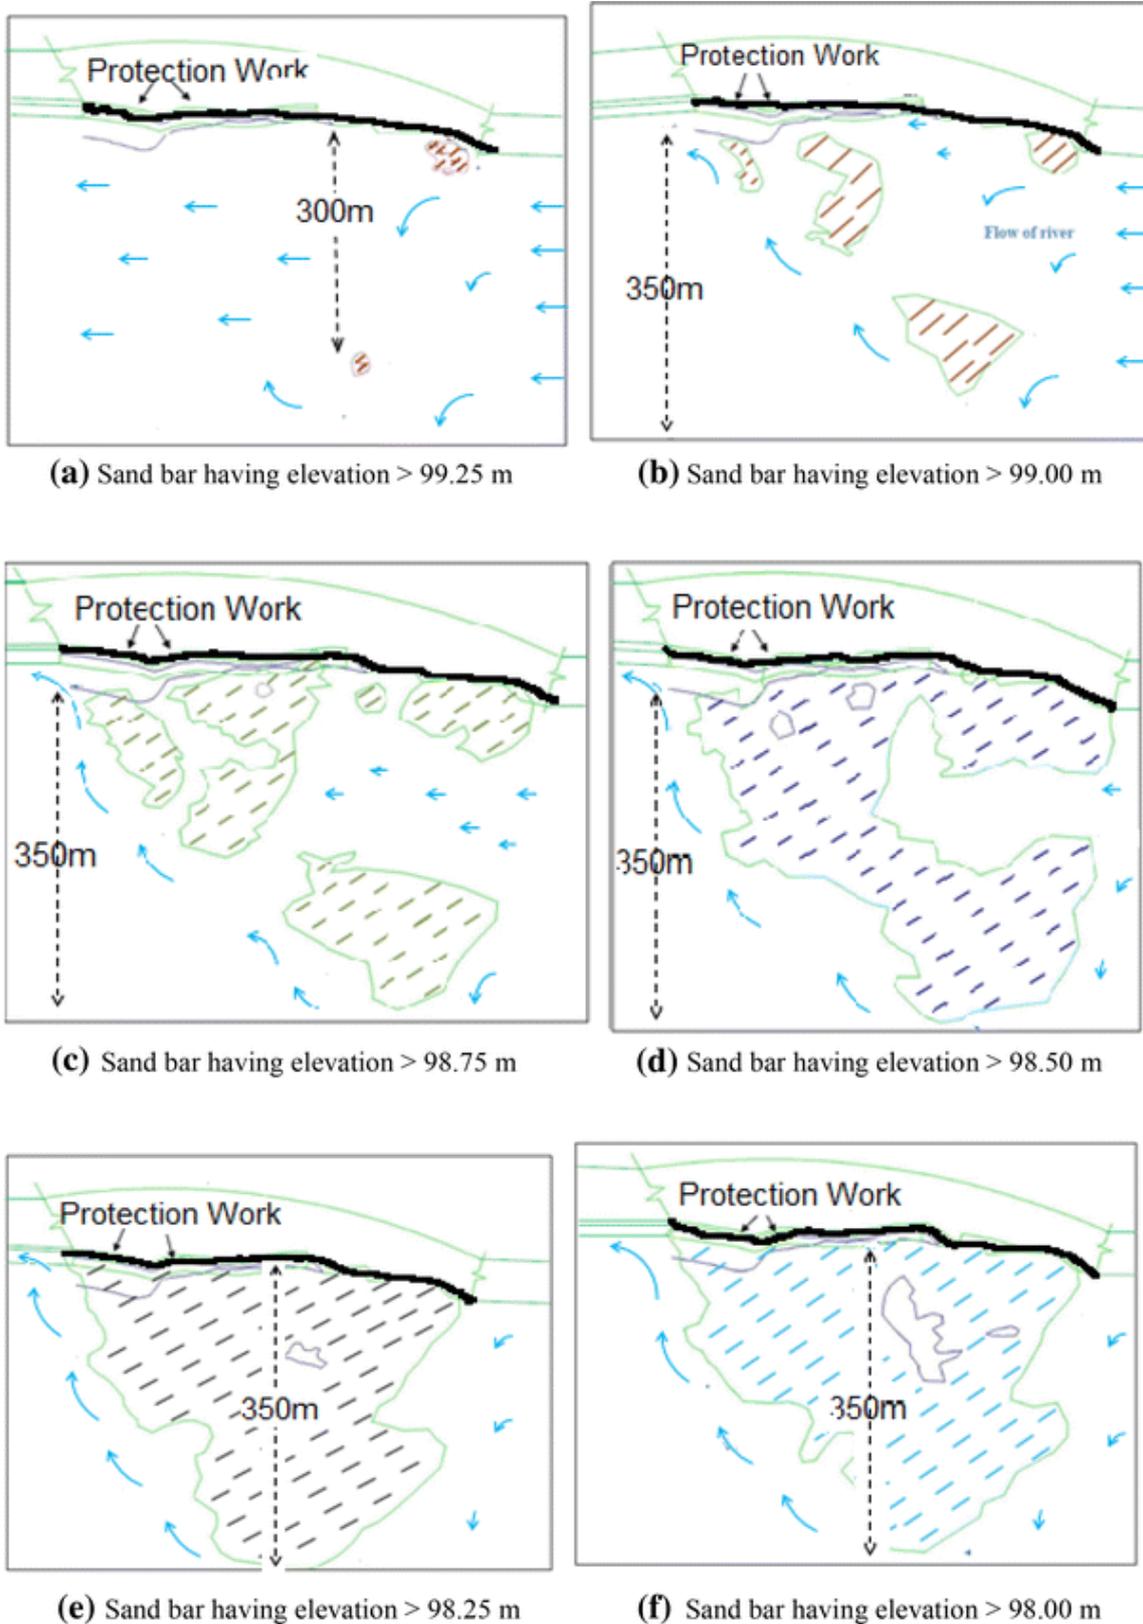
FIGURE. 5

SAND BAR HAVING ELEVATION A >99.25 M; B >99.00 M; C >98.75 M; D >98.50 M; E >98.25 M; F >98.00 M

As the speed of stream is diminished after establishment of the bed cook's garment the primary indication of siltation is seen close to the upstream end of the bed smock (Fig. 5a). Figure 5a likewise demonstrates start of mid-channel siltation at an area around 300 m far from the bank showing redirection of the waterway stream bearing far from the insurance work. As the surge water retreats the siltation territory develops around the underlying mid-channel sand bar and furthermore close to the downstream side of the starting smock (Fig. 5b-d). It demonstrates progressive redirection of the waterway water stream channel far from the bank. Figure 5 demonstrates that the zone of impact of the bed assurance work through propelling overskirt stretches out up to remove 350 m from the bank into the stream which is about 30 times that of the 10.5 m width of the starting cover.

As the surge water subsides the stream of water is bit by bit diverted far from the bank, the reroute additionally starts siltation in the upstream of the assurance measure and the sand bar logically grows much past the upstream end purpose of the insurance measure.

Figure 5e, f demonstrates that in spite of the fact that the starting smock effectively redirected the stream water stream channel far from the bank close to the upstream end of the insurance measure and brought about advancement of another sand bars no siltation happens quickly past the downstream end of the assurance measure and the waterway channel returns strongly towards the bank just past the downstream end of the bed cook's garment. Since the bank soil is erodible, as obvious from the geotechnical testing, this sharp stream of the waterway towards the bank downstream of the security work has made it profoundly powerless against impinging stream disintegration.

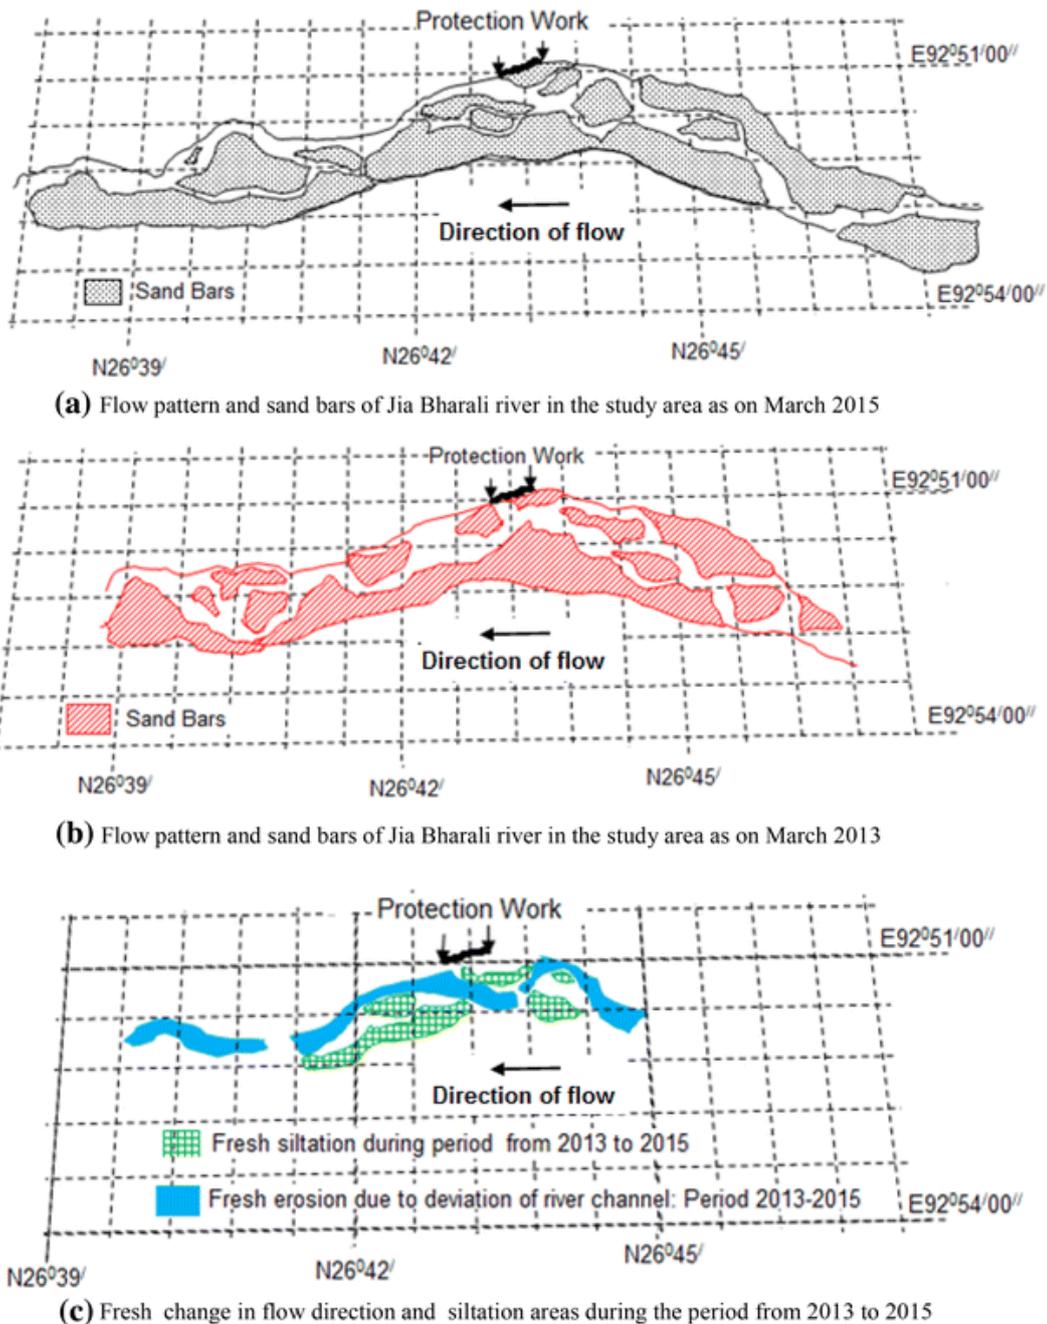
FIG. 6

FLOW PATTERN AND SAND BARS OF JIA BHARALI RIVER A IN THE STUDY AREA AS ON MARCH 2015; B IN THE STUDY AREA AS ON MARCH 2013. C FRESH CHANGE IN FLOW DIRECTION AND SILTATION AREAS DURING THE PERIOD FROM 2013 TO 2015.

Figure 6 plainly demonstrates that the waterway channel has strongly returned into the bank. This channel has begun new bank disintegration in the prompt downstream of the insurance work.

Jia Bharali stream, after establishment of the assurance measure in the western bank, has logically come nearer to a similar bank in the downstream of the security work. It, consequently, has additionally expanded the powerlessness of the bank to disintegration in quick downstream of the security measure. In this downstream segment of the stream, amid the time of 2 years from 2013 to 2015, the waterway has changed course towards the western bank bringing about bank disintegration and arrangement of mid-channel sand bars. This has made an earnest need to ensure the waterway bank facilitate downstream of the assurance work under review.

zone of a similar bank. Such venture arranging needs to incorporate measures to lessen downstream bank disintegration especially if the geotechnical properties of the bank soil in the downstream extend are observed to be poor.
