# Failure Analysis of a Hot Forged SAE 4140 Steel Kingpin

**Abstract**— The fifth wheel and kingpin connection system, a critical part of heavy vehicles, provides the link of tractor and trailer. The kingpin is usually manufactured by hot forging. A part manufactured by this process was assembled in a fifth wheel of an off-road truck and presented an early failure. The truck was used in a quarry until the kingpin failure, three months later. One process issue that can occur in hot forged products is a poor grain structure due to overheating, burning and cavitation. The Scanning Electron Microscopy (SEM) analysis of the failed part showed the presence of cavitation. However, the failure analysis results evinced that cavitation was not the main cause of the fracture, but a combination of wear, impact fatigue and overload.

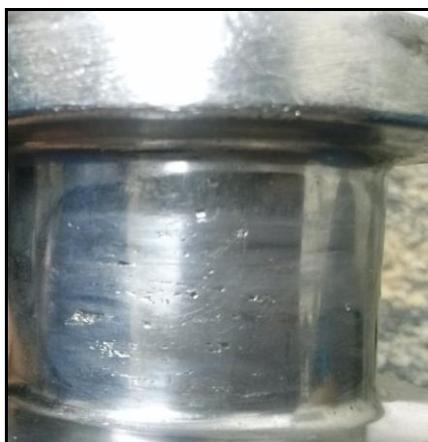
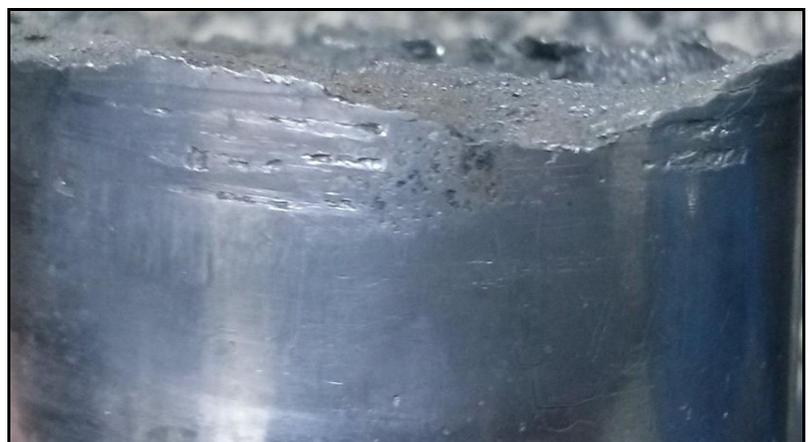
**FIGURE 1. IMAGES OF TOPSIDE (A) AND UNDERSIDE (B) OF THE FRACTURED KINGPIN.**

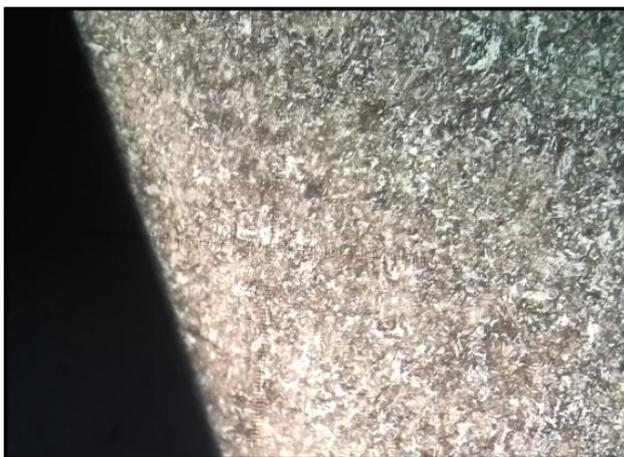
**FIGURE 2. OPTICAL MICROSCOPE IMAGE OF THE KINGPIN STEEL MICROSTRUCTURE SHOWING TEMPERED MARTENSITE AND BAINITE. ETCHANT: NITAL 3%.**

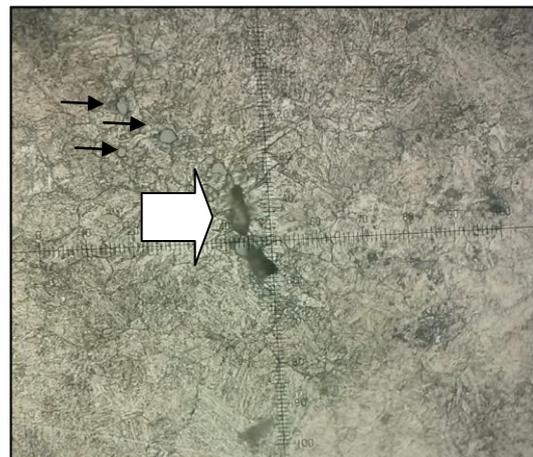
**FIGURE 3. OPTICAL MICROSCOPE IMAGE OF THE KINGPIN MICROSTRUCTURE SHOWING PRIOR AUSTENITIC GRAIN BOUNDARIES. GRAIN SIZE: BETWEEN 5 AND 6 ACCORDING TO ASTM E 112 [4]. THE THICK ARROW SHOWS CAVITATION AND THIN ARROWS SHOW SULFIDE INCLUSIONS. ETCHANT: PICRAL 2%.**

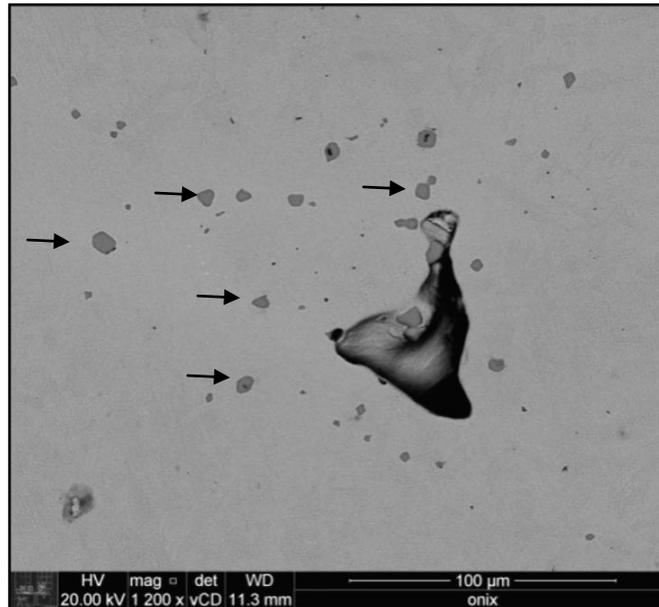
An optical microscopy metallographic analysis and SEM and X-ray energy dispersive spectrum (EDS) analyses were performed in order to observe the microstructure. Samples were taken from a region about 5 mm under the fracture surface of the kingpin. The polished surface of one sample was etched with nital 3% in order to investigate the microstructure and the other sample was etched with picral 2% in order to observe the prior-austenite grain boundaries. The optical microscope images are shown in Fig. 2 and Fig. 3. The steel microstructure is composed by tempered martensite and bainite. Cavitation and sulfide inclusions can be seen in Fig. 3. Figure 4 is a SEM image in which the cavitation in prior-austenite grain boundaries and MnS inclusions can be observed. The composition of the inclusions was confirmed by the EDS analysis. A mechanism that occurs during the cavitation phenomenon is the dissolution of the manganese sulfide inclusions and subsequent precipitation as globular particles upon cooling. Then a new distribution of MnS forms and it is not uniform, such as a cluster around the cavity.

**FIGURE 4. SEM IMAGE OF THE KINGPIN. THE THICK ARROW SHOWS CAVITATION AND THIN ARROWS SHOW MANGANESE SULFIDE INCLUSIONS AROUND CAVITATION.**

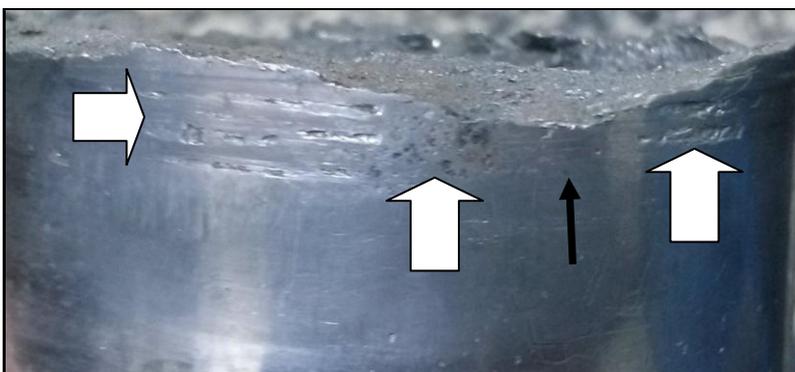
Figure 5 shows the underside of fractured kingpin with some wear points and pits that may be caused by a combination of contact fatigue, with rolling and sliding, and impact fatigue mechanisms) [1]. Figure 6 shows the fracture surface of the underside of fractured kingpin. The picture plane is normal to the kingpin axis. The contour of the fractured piece, instead of presenting the circular shape of the original kingpin cross-section, is quite irregular, showing evidence of severe deformation. The subsurface fracture origin on the wear region can be observed in Fig. 7.

**FIGURE 5. IMAGE OF UNDERSIDE OF FRACTURED KINGPIN. THICK ARROWS SHOW WEAR AREAS. THIN ARROW SHOWS THE FRACTURE ORIGIN.**

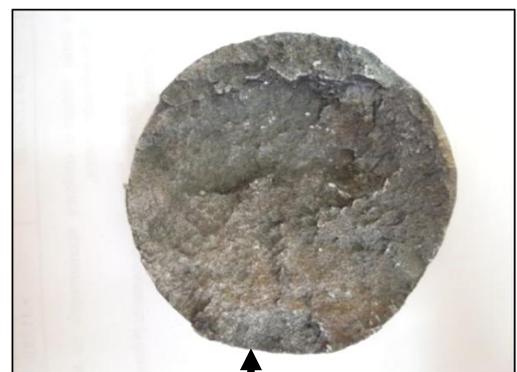
**FIGURE 6. IMAGE OF THE FRACTURE SURFACE OF THE UNDERSIDE OF FRACTURED KING PIN. THE ARROW SHOWS THE FRACTURE ORIGIN.**

The image in Fig. 6 shows that global behavior of the part was ductile because of the amount of deformation that occurred on the circumference of kingpin cross section. This fact is in accordance to the surface hardness measured (36 HRC) which is not a brittle condition for this kind of steel. The numerical analysis was able to predict the plastic deformation behavior in the kingpin surface due to the severe service conditions. The random nature of the applied loads and changes in loading point due to maneuvering justify the irregular deformation pattern observed in the kingpin cross section. It was observed that the fracture origin is next a region with wear aspect and pits. In addition, the failure origin is subsurface which leads to the conclusion that the cause of the crack nucleation involves a kind of contact fatigue and impact fatigue.

The brittle appearance along the fracture surface (Fig. 6) suggests that, besides the ductile fracture aspect of external surface of king pin, some kind of local embrittlement occurs. This embrittlement could not be caused by cavitation phenomenon because the fracture propagation mechanism is not intergranular, especially in the area next to the fracture origin. The transgranular fracture propagation mechanism next to the fracture origin is common when there is any kind of overload. The finite element analysis showed the possibility of overload occurrence. The inclusion clusters are not the main cause of the nucleation of fatigue crack because the fracture origin does not show any dimples. The cavitation and the manganese sulfide precipitation could contribute to the propagation but they are not the root cause of the failure. Moreover, the tendency to exhibit cleavage rather than a ductile fracture mode is one of the main features of impact fatigue of steels [16]. Then, the observed embrittlement mechanism could be due to impact fatigue [17].

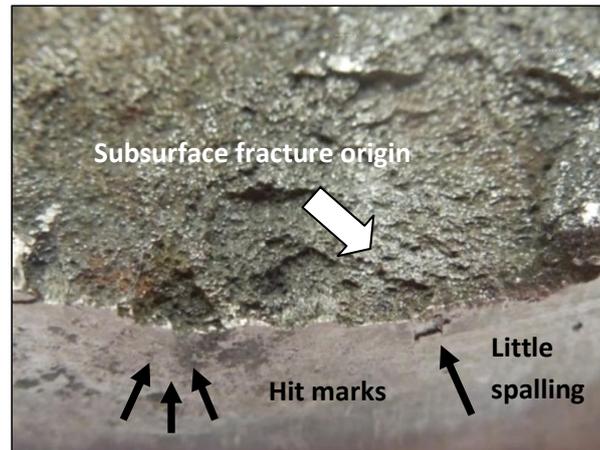
**FIGURE 7. FRACTURE SURFACE OF THE KINGPIN. THICK ARROW SHOWS THE FRACTURE ORIGIN AND THIN ARROWS SHOW THE SPALLING AND HIT MARKS.**

The ductile (plastic) deformation of the kingpin cross section possibly enabled the subsequent occurrence of impact fatigue. This deformation caused a clearance between the fifth wheel and kingpin which was the sufficient condition to enable impact loads to occur. The plastic deformation of materials under impact fatigue mainly concentrates around the points of impact loading [14]. Furthermore, the obliquity of the impact, as considered in the numerical analysis, as a consequence of the ground irregularities was considered by Svenzon [15] of fundamental importance for the creation of impact fatigue failure. The observed pits show a peculiar brittle aspect of little spalling that could be caused by an impact against a hardened case such as a martensitic microstructure (Fig. 2 and Fig. 7).

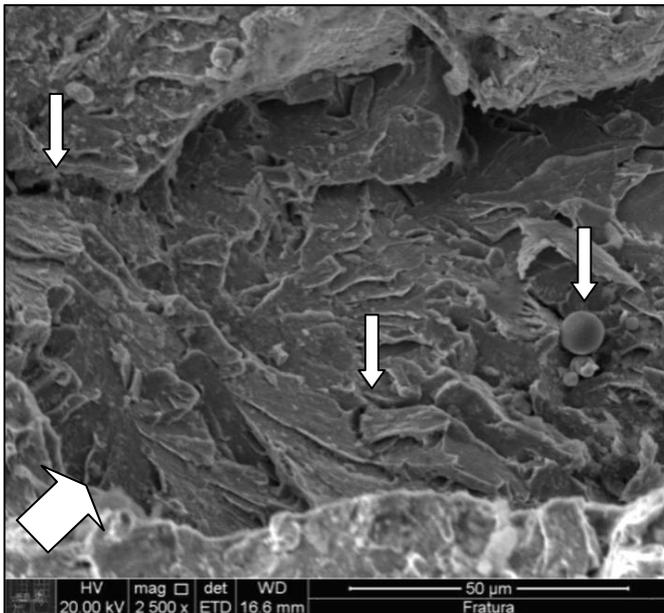
Scanning electron microscopy (SEM) analysis was performed on the kingpin fracture surface. Fig. 8 shows the fracture mechanism next to the fracture origin. The main fracture mechanism observed is quasi-cleavage [6], which is a possible fatigue propagation mechanism for the SAE 4140 steel in as verified by Vargas-Arista et al [7]. There is no precipitation in the subsurface fracture origin. The fracture propagation mechanism changes along the fracture surface to a mixed mechanism of dimples and a few regions of intergranular fracture (Fig. 9).

**FIGURE 8. SEM IMAGE OF FRACTURE SURFACE OF KINGPIN, NEXT THE FRACTURE ORIGIN, SHOWING QUASI-CLEAVAGE FRACTURE MECHANISM. THICK ARROW SHOWS THE FRACTURE ORIGIN. THIN ARROWS SHOW A CEMENTITE PARTICLE, IDENTIFIED BY EDS (X-RAY ENERGY DISPERSIVE SPECTRUM), AND SECONDARY CRACKS.**

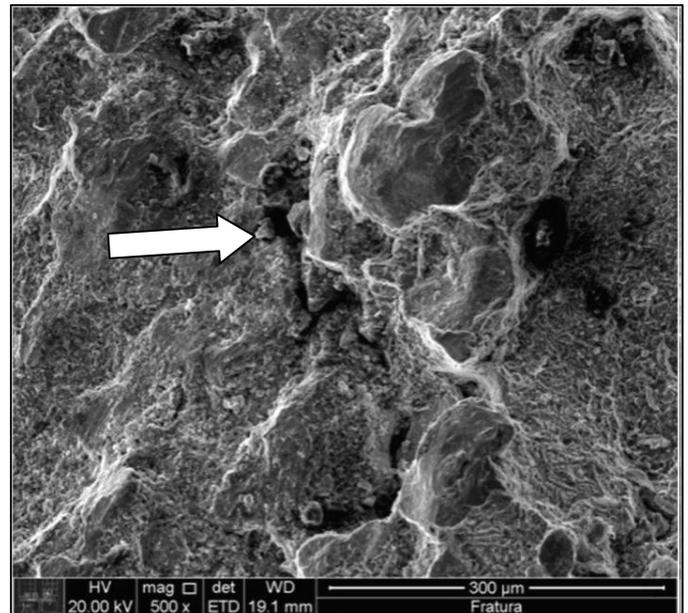
**FIGURE 9. SEM IMAGE OF FRACTURE SURFACE OF KINGPIN, FAR FROM THE FRACTURE ORIGIN, SHOWING A MIXED FRACTURE MECHANISM: DIMPLES AND A FEW OF INTERGRANULAR MECHANISM. ARROW SHOWS AN INITIAL CAVITATION.**

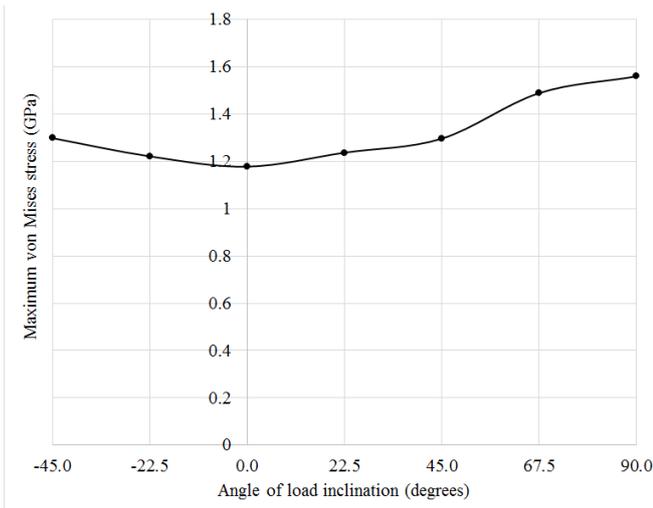
Altogether, seven problems were simulated with the numerical model described above, varying the angle of load inclination showed in Fig. 10. The use of different angles is because of the problem complexity resulting from the service conditions in a quarry. When the truck wheel step over a stone or other ground irregularity, the vertical component of the kingpin load may increase, but the true angle of inclination is very difficult to be obtained, as it depends on the truck speed, the irregularity size and the fifth wheel damping system. According to Fig. 11 and Fig. 12, as the angle of inclination with respect to the horizontal direction increases, the von Mises stress and thus the plastic strains increase too. These results reinforce the idea that the use of the truck in such severe operation conditions like those present in a quarry may result in impact stresses leading to plastification, which in turn increases the strains and, thus, the clearance between the fifth wheel and the kingpin (see Fig. 11). Under these conditions, the impact between such components becomes more and more severe.

**FIGURE 11. MAXIMUM VON MISES STRESS VERSUS THE ANGLE OF LOAD INCLINATION.**

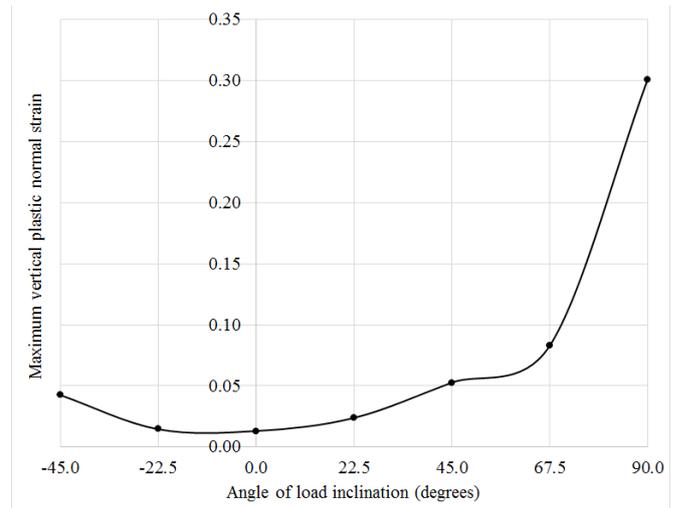
**FIGURE 12. MAXIMUM VERTICAL PLASTIC NORMAL STRAIN VERSUS THE ANGLE OF LOAD INCLINATION.**

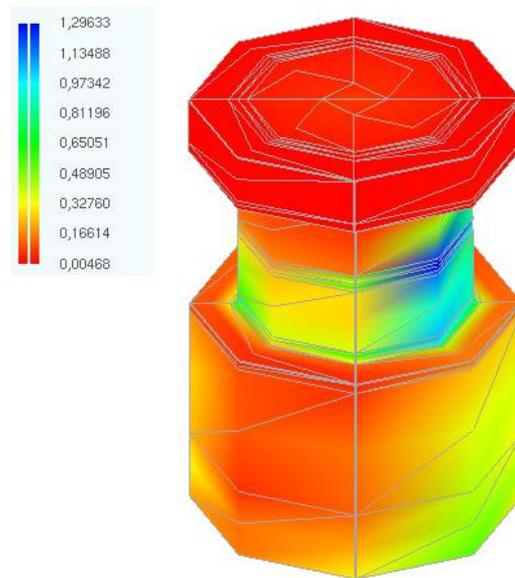
As expected, the von Mises stress and, thus, the plastification are higher at the region around the applied force (see Fig. 13). This fact is in accordance with the failure analysis performed in the present study, as it confirms the occurrence of plastic (or ductile) deformation at the lateral surface of the kingpin.

**FIGURE 13. VON MISES STRESS (GPa) FOR THE CASE IN WHICH THE LOAD INCLINATION ANGLE IS 45°.**
