# Mitigation of Disasters and Civil Engineering

**Abstract**—Natural Disasters are acts of God as a result of human violation and lapses at large at innumerable levels which are never recognized and subsequently lead to irreparable damages over a period of time. Civil engineers have a great role in mitigating the effect of it and recovering the victimized areas. This can be done by development of technologies for enhancement of infrastructure, design and construction of infrastructures with high potential disaster-resistance, active participation in the recovery and redevelopment works after the disaster. Not only the planning, setting up and maintenance are the core responsibilities, it is also the responsibility of the Civil Engineer to ensure that the provisions are as per standard norms laid down by various International Relief organizations like the World Bank, International Red Cross etc. This paper aims to list the types of Disasters that frequently affect the structures, Role of Civil Engineers in Mitigation, Relief and Rehabilitation work. It also study the effect of disasters on building structures citing few examples of building disasters.

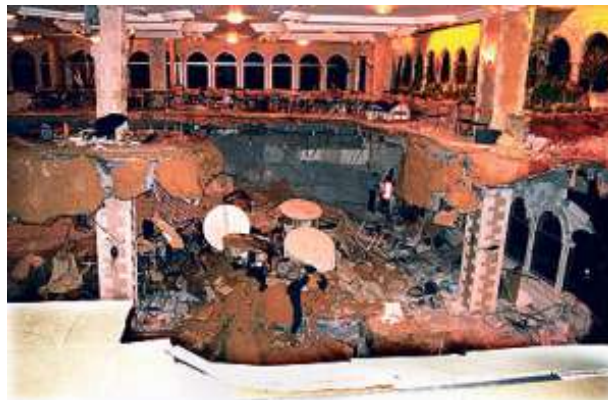
**Fig.1 Versailles Wedding Hall, located in Talpiot, Jerusalem**

The Versailles Wedding Hall, located in Talpiot, Jerusalem, is the site of the worst civil disaster in Israel's history.

- the incident was taken place during the wedding of Keren and AsafDror on May 24, 2001,
- a large portion of the third floor of the four-story building collapsed.
- 23 people died on the spot through two stories, including the groom's 80-year-old grandfather and his three-year-old second cousin, the youngest victim.
- 380 were injured, it includes the bride who suffered serious pelvic injuries lead to surgery.

- The Pal-Kal method of constructing light-weight coffered concrete floor systems were pointed as the reason for the collapse.
- A few weeks before the collapse, the wedding hall owners decided to remove some partitions. With the load path eliminated, the floor above began to sag several inches.
- The owners viewed the sagging floor primarily as a cosmetic problem, and attempted to level it with additional grout and fill.

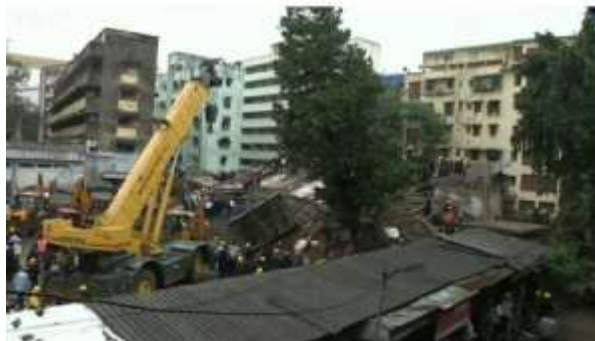
Fig.2 Residential Building Collapse, Mumbai, India

*A residential building collapsed in the Mazagaon area of Mumbai city in Maharashtra a state in India.*

- The incident happened on September 27th 2013
- 61 people died and 32 others were injured in the disaster.
- The collapse occurred after a mezzanine floor was built without permission in an office-warehouse on the ground floor of the building.
- Officials said the families living in the building had been asked by the municipality to leave it earlier that year.

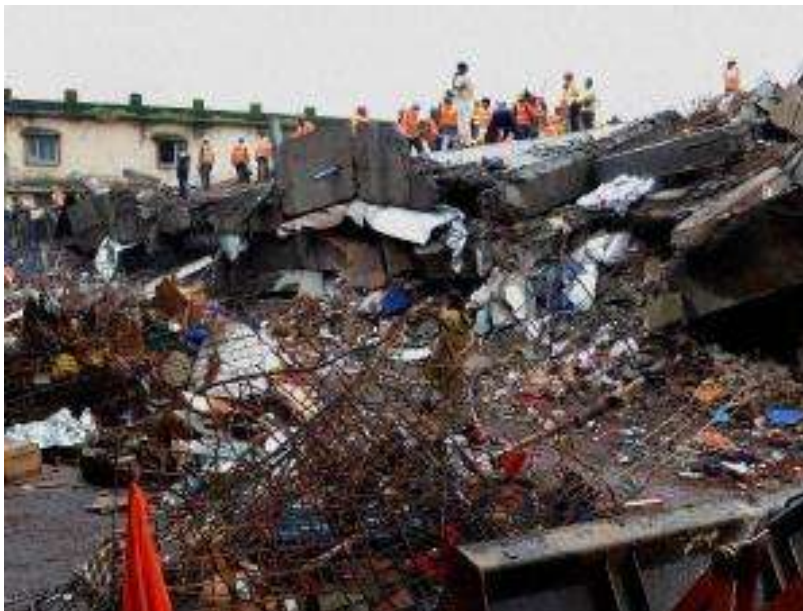
**Fig.3Thane Building Collapse, India**

A building collapsed on 4 April 2013 in Mumbai a place near to Thane in Maharashtra, India .It was one of the worst disaster among the building collapse. The death has raised to 74 people (including children) died.The builders, engineers, municipal officials and other responsible parties were arrested as the building was occupied without an occupancy certificate. Around 100to 150 families from middle income group were residing in the building.

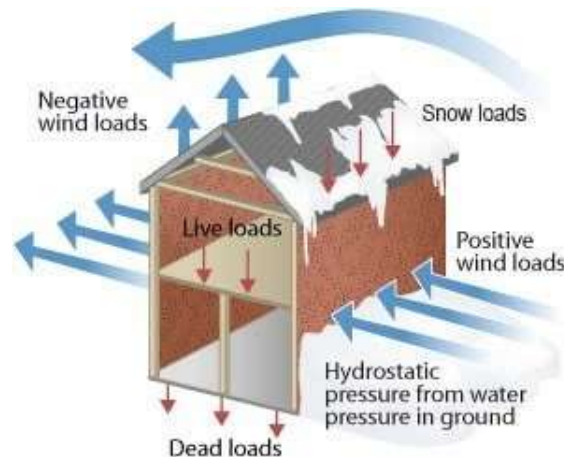
**Fig.5 Types of Loads**

Building should be designed in such a way that they can resist high wind pressure. Building should be designed in such a way that they can resist the high water pressure of the flood.

The design loads are always multiplied by a factor which is known as Factor of Safety.

The different factor of safety is applied to different load combinations in accordance with the probability of occurrence of loads. E.g.:  $(1.5) \times \text{Dead load} + (1.5) \times \text{Live load}$
