Influence of Operating Conditions of the Steel Cord on the Structure and Selected Mechanical and Technological Properties of High Carbon Steel

Dominika Grygier[1], Małgorzata Rutkowska-Gorczyca[2]

Wrocław University of Technology, Department of Materials Science, Strength and Welding Technology, ul. Smoluchowskiego 25 50-372 Wrocław, Poland

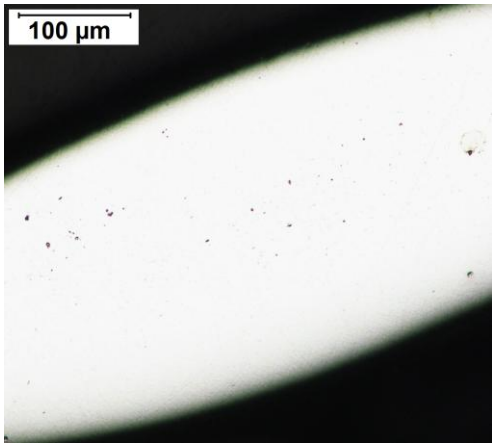
The microscopic observations of the tested materials in the non-etched state have shown presence of non-metallic inclusions, mainly in the form of oxides. The contaminations were distributed punctually and appeared in quantity from standard 2 to 3 according to PN-64/H-04510 (Fig.1 and 2). It has to be kept in mind that fatigue strength of steel wires is highly depending on metallurgic purity of the material [5,3,18,19]. Presence of non-metallic inclusions, especially in the form of brittle oxides, may cause lowering of the material ductility hindering by that the technological processes, and in specific cases lead even to wire cracking during operation.

FIG. 1. STRUCTURE OF THE STANDARD SPECIMEN, VISIBLE FINE NON-METALLIC OXIDE INCLUSIONS. NON-ETCHED STATE. LM

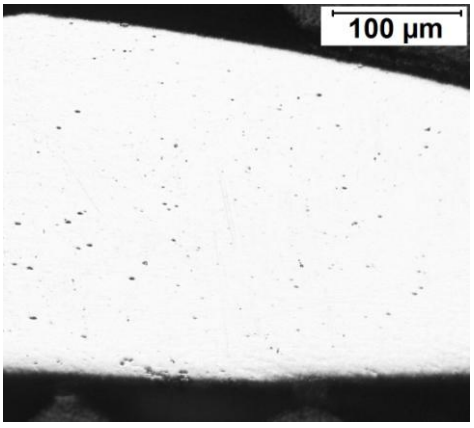
FIG. 2. STRUCTURE OF THE EXPLO 1 SPECIMEN, CLEARLY VISIBLE NON-METALLIC INCLUSIONS IN THE FORM OF PUNCTUALLY DISTRIBUTED OXIDES. NON-ETCHED STATE. LM

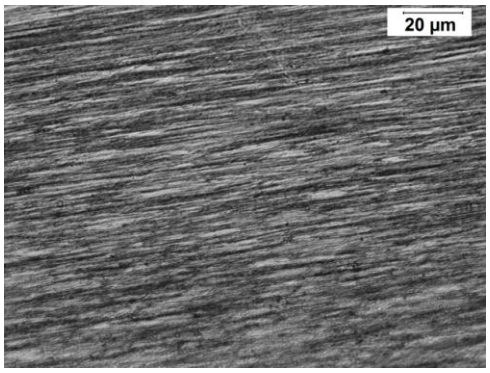
FIG.3. MICROSTRUCTURE OF STANDARD SPECIMEN MATERIAL, VISIBLE STRONG PLASTIC STRAIN OF MATERIAL BEING THE RESULT OF THE APPLIED DRAWING PROCESS. ETCHED STATE. LM

The microscopic tests performed at sections taken in opposite direction to the plastic working have shown that all the tested wires, according to the recommendations of the PN-EN 10323:2005 (U) standard, were made of unalloyed pearlite steel. As a result of microscopic observations of the specimens made in direction of plastic working it has been found that the tested materials are characterised with high degree of plastic strain of the order of 80-90%, being the result of the cold drawing process applied in technology of steel wires (Fig. 3 and 4).

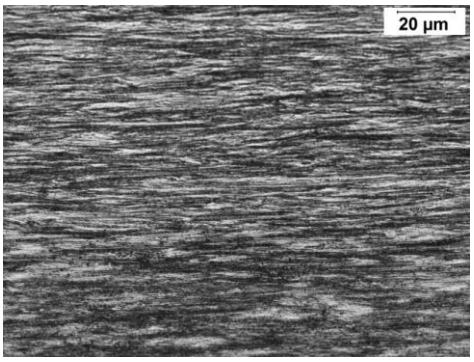
FIG.4. STRUCTURE OF THE MATERIAL AFTER OPERATION IN THE CAR TIRE (EXPLO 2), VISIBLE CLEAR PLASTIC STRAIN AMOUNTING TO ABOUT 80%. ETCHED STATE. LM

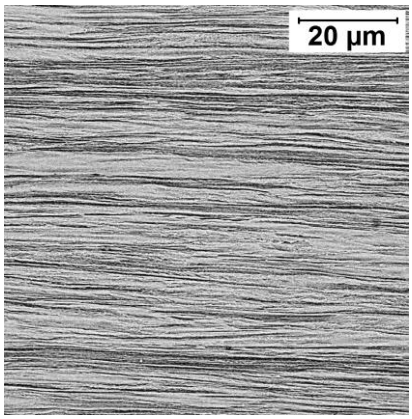
FIG. 5. MAGNIFIED ARE SHOWN IN FIG. 3, VISIBLE THE COHERENT STRUCTURE OF THE STANDARD SPECIMEN. SEM

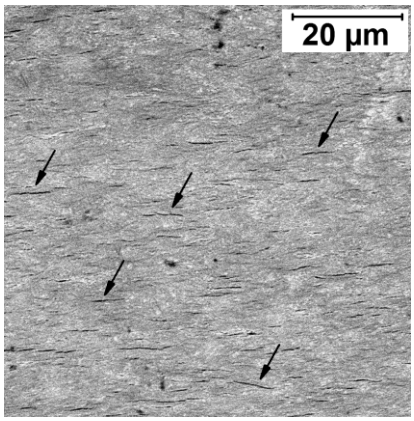
FIG. 6. MAGNIFIED AREA SHOWN IN FIG. 4, CLEAR DELAMINATIONS OF THE MATERIAL POSITIONED IN DIRECTION OF THE APPLIED PLASTIC WORKING. SEM

The initial microscopic tests have not shown the significant differences in structure of the tested specimens, until the further observations with application of the scanning electron microscopy, which revealed the clear influence of operation on structure of the tested material. The results of the microstructure analysis have shown, that during operation of the tire the belt material is destroyed (Fig. 5 and 6). The presence of frequent structure delaminations was observed, oriented in direction of plastic working of the material, the probable cause of the material discontinuities was presence of non-metallic inclusions in the tested materials [5,11,3]. It can be expected, that the observed changes in the structure, will significantly influence the strength and technological properties of the materials, and after exceeding the critical size of the failure may even cause cracking of the wires.
