Investigation on Performance of Jia Bharali River Bank Protection Measure Using Geotextile Bags

Mayank Kumar Gupta

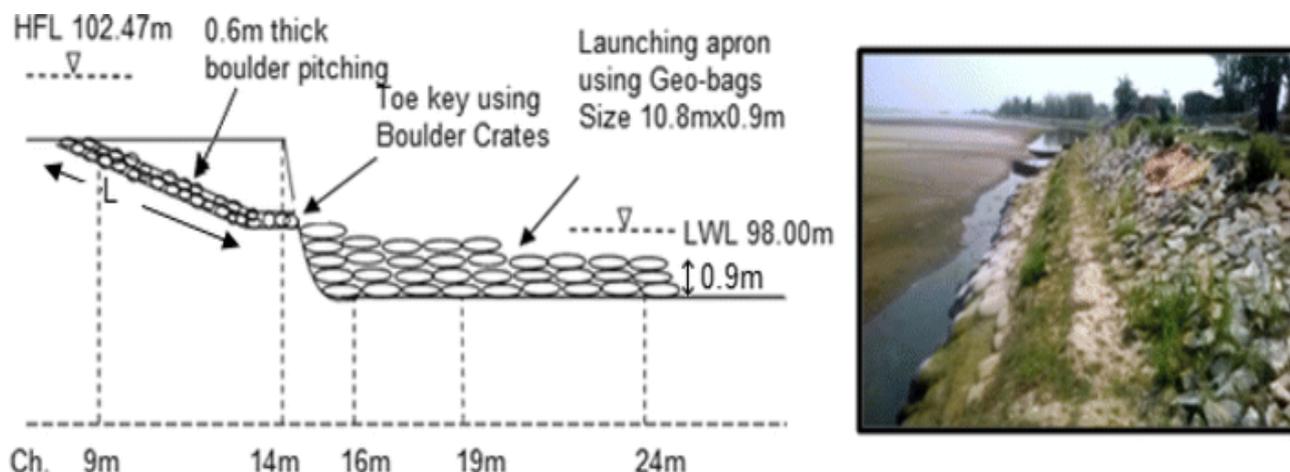
FIGURE 3: TECHNICAL DETAILS OF THE BANK PROTECTION WORK INSTALLED BY WATER RESOURCES DEPARTMENT ASSAM

The detail of the protection work designed and installed at the river bank by the Water Resources Department (WRD) is shown in Fig. 3 and Table 2.

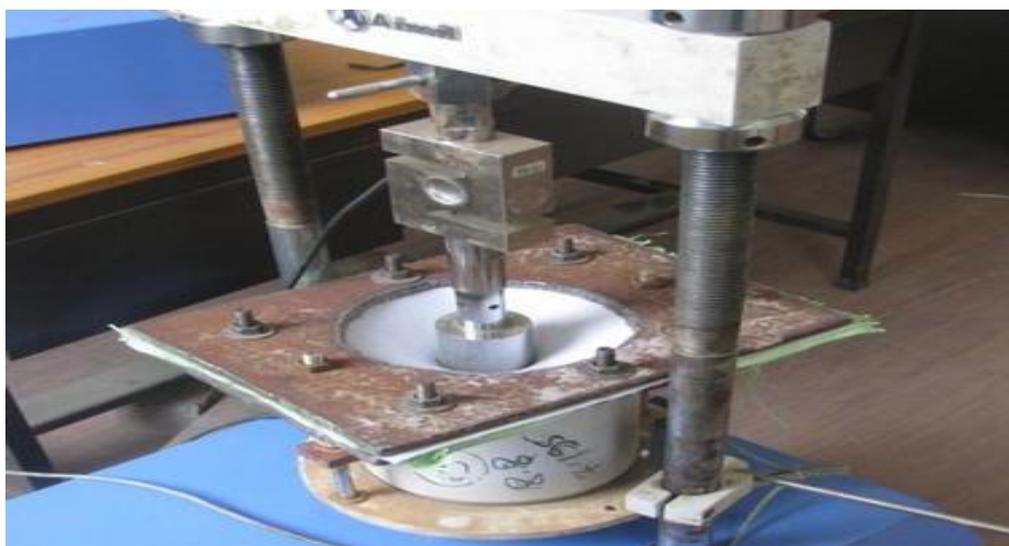
FIGURE 4 CBR TSSTING

The geotextile material used in the project is of nonwoven type. A general inspection of the used and unused samples of the geotextile showed that the geotextile, after 3 years of exposure to field condition, has not shown any significant deterioration. The laboratory test results are shown in Table 3.

The results show that the nonwoven geotextile bag material used in this work, even after 3 years of field exposure, has not shown signs physical deterioration with only 15 % drop in its strength.
