# Failure Analysis of a Hot Forged SAE 4140 Steel Kingpin

**Abstract**— The fifth wheel and kingpin connection system, a critical part of heavy vehicles, provides the link of tractor and trailer. The kingpin is usually manufactured by hot forging. A part manufactured by this process was assembled in a fifth wheel of an off-road truck and presented an early failure. The truck was used in a quarry until the kingpin failure, three months later. One process issue that can occur in hot forged products is a poor grain structure due to overheating, burning and cavitation. The Scanning Electron Microscopy (SEM) analysis of the failed part showed the presence of cavitation. However, the failure analysis results evinced that cavitation was not the main cause of the fracture, but a combination of wear, impact fatigue and overload.

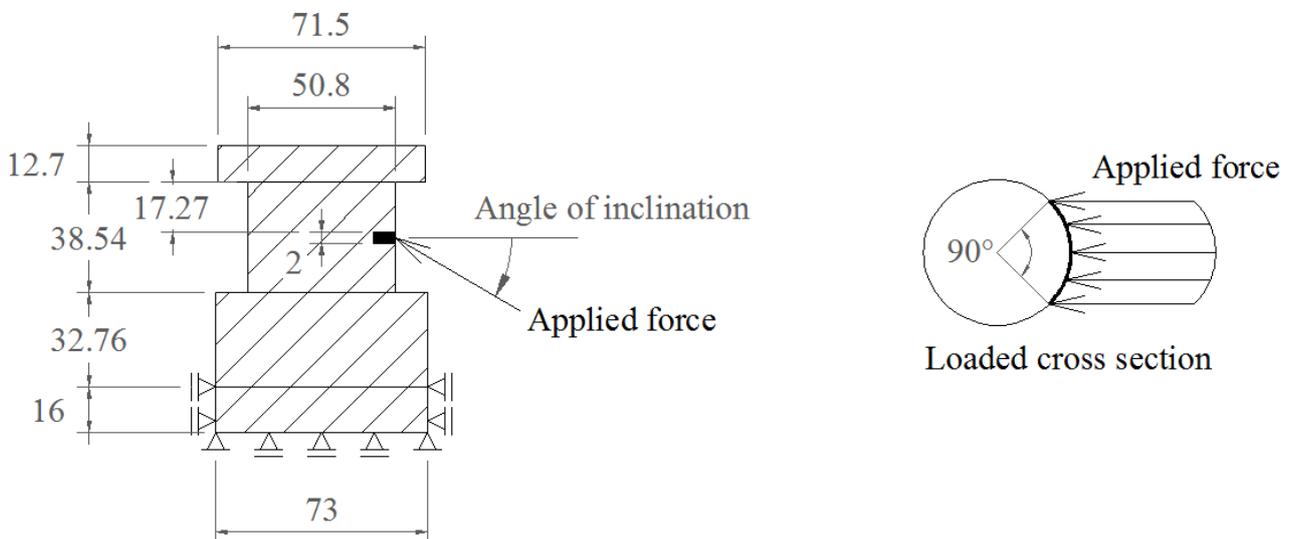
**FIGURE 10. FINITE ELEMENT MODEL OF THE KINGPIN (dimensions in mm).**

Altogether, seven problems were simulated with the numerical model described above, varying the angle of load inclination showed in Fig. 10. The use of different angles is because of the problem complexity resulting from the service conditions in a quarry. When the truck wheel step over a stone or other ground irregularity, the vertical component of the kingpin load may increase, but the true angle of inclination is very difficult to be obtained, as it depends on the truck speed, the irregularity size and the fifth wheel damping system. According to Fig. 11 and Fig. 12, as the angle of inclination with respect to the horizontal direction increases, the von Mises stress and thus the plastic strains increase too. These results reinforce the idea that the use of the truck in such severe operation conditions like those present in a quarry may result in impact stresses leading to plastification, which in turn increases the strains and, thus, the clearance between the fifth wheel and the kingpin (see Fig. 11). Under these conditions, the impact between such components becomes more and more severe.
