The influence of the environment factors and the surface treatment on Stress Corrosion Cracking of Type 304 Austenitic Stainless Steel

Abstract— The aim of this work is to understand the combined effects of stress, temperature, humidity and chloride ion on the susceptibility of stress corrosion cracking (SCC) of type 304 austenitic stainless steel. The occurrence of SCC was investigated using the as received (cold work), sensitized samples those are exposed in the environmental test chamber at 40°C and 70°C, respectively. The humidity from 40% to 70% RH with gradient of 10% was applied during the corrosion test lasted 720h. The results showed the environmental conditions where SCC crack can be occurred and where it can be avoided. The initiation and the propagating of SCC crack on the flat and U-bend specimens were grown up to correspond to the increasing of test temperature. Very high stress cracking can be observed in the period of low relative humidity (40%) and temperature (40°C).

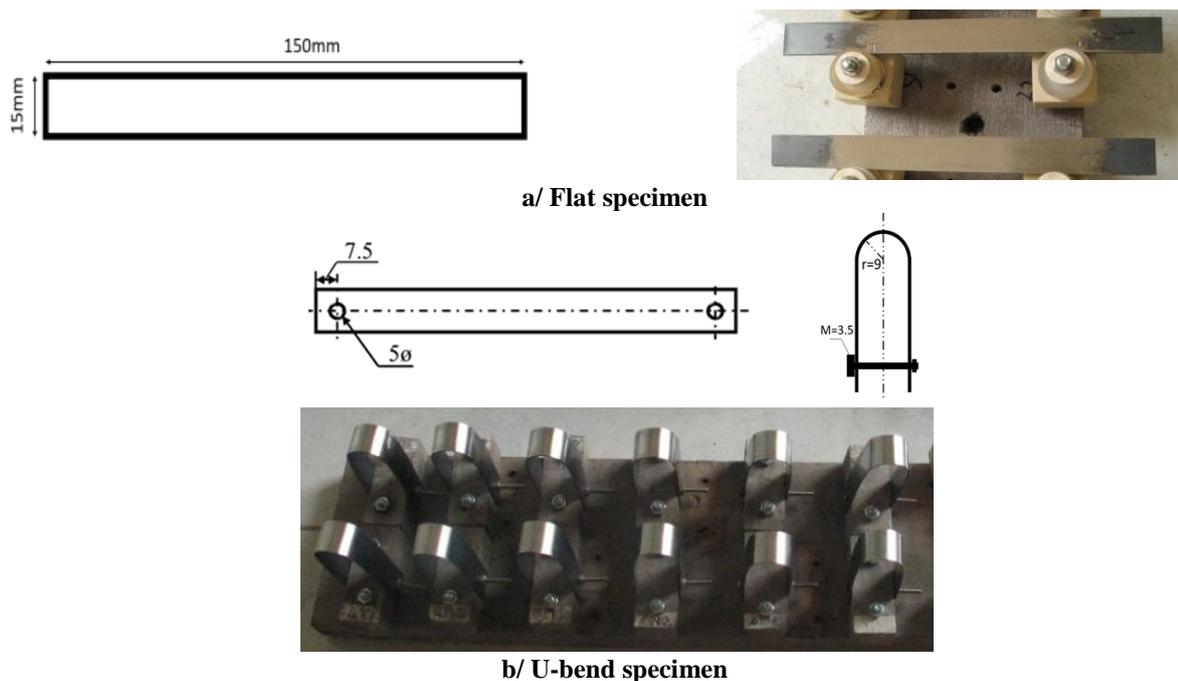
FIGURE 1. Flat (a) and U-bend (b) specimens

Type 304 austenitic stainless steels (0.065C, 0.58Si, 1.9Mn, 0.014P, 0.022S, 8.789Ni, 18.56Cr, %mass, Fe: bal) with thickness of 0.8mm was cut into 15mm x150mm as the samples. The tests were carried out using the flat and U-bend specimens fabricated from the above steel (Fig.1).

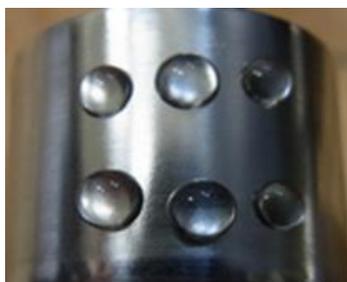
FIGURE 2.U-bend specimen with freshly deposited droplets

Both flat and U-bend samples were dropped with six droplets of chloride solution as shown in Fig.2. For the U-bend samples, two big drops were deposited on the top area and four smaller ones on the side area.

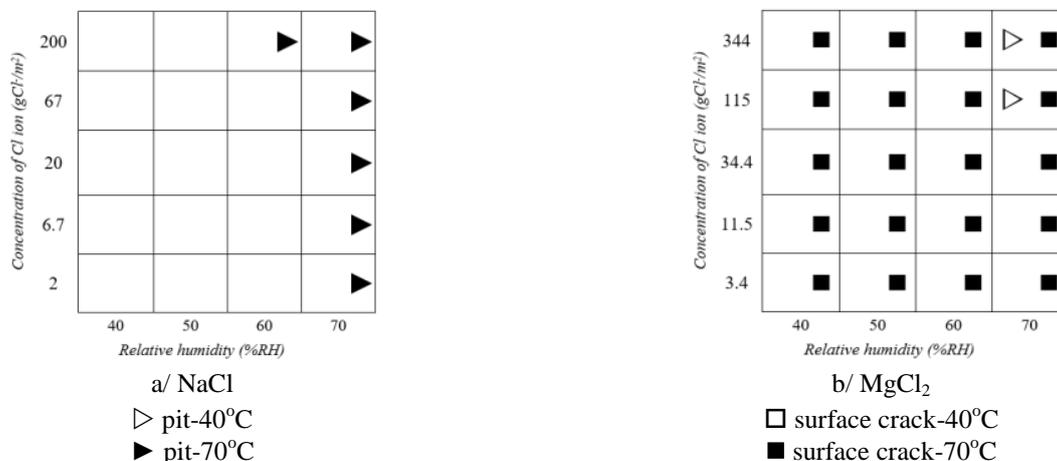
FIGURE 3. The corrosion behavior of the as-received flat samples deposited with saturated NaCl droplets (a) and MgCl₂ droplets (b)

All samples deposited with various concentration of chloride ions were exposed in the environment chamber at 40°C and 70°C which combined with four different levels of 40%, 50%, 60% and 70%RH. The tests were terminated after 30 days exposed. The results for type 304 as-received flat samples are presented in Fig 3.

It is recognized that concentrated NaCl solutions were not severe enough for SCC occurred on the type 304 as-received flat samples at 40°C. Even at the high temperature (70°C), only pitting was observed at 70%RH (Fig.3.a).

For the MgCl₂ deposited samples, almost no failure occurred at 40°C, but only pitting corrosion appeared at 70%RH on the samples deposited with high chloride levels – saturated and three times diluted. (Fig.3b and 4a). At 70°C, the cracks appeared on all the samples, irrespective of values of relative humidity and concentration of chloride ion, the pit size was larger and the cracks initiated from the pits were observed (Fig. 3b and Fig. 4b). The above results can be explained as follows: The chloride amount in one droplet of MgCl₂ solution is always higher than that in one droplet of NaCl solution, in addition, MgCl₂ solution is acidic (with pH = 5.7), which accelerated the metallic soluble react. Because MgCl₂ deliquesced at lower

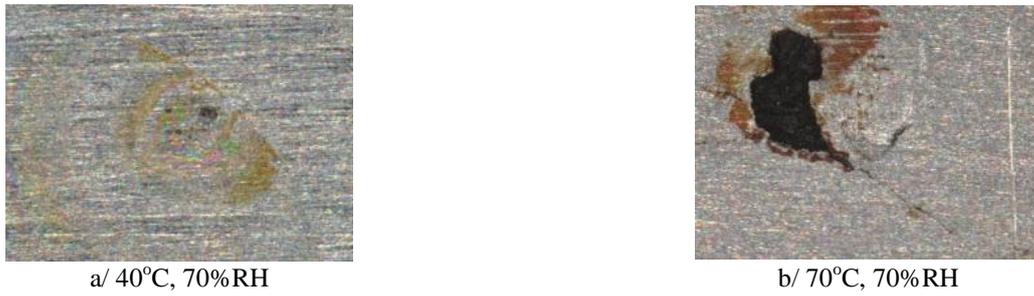
FIGURE 4. The appearance of the as-received flat samples with saturated MgCl₂ droplets after 30 days, (160x)

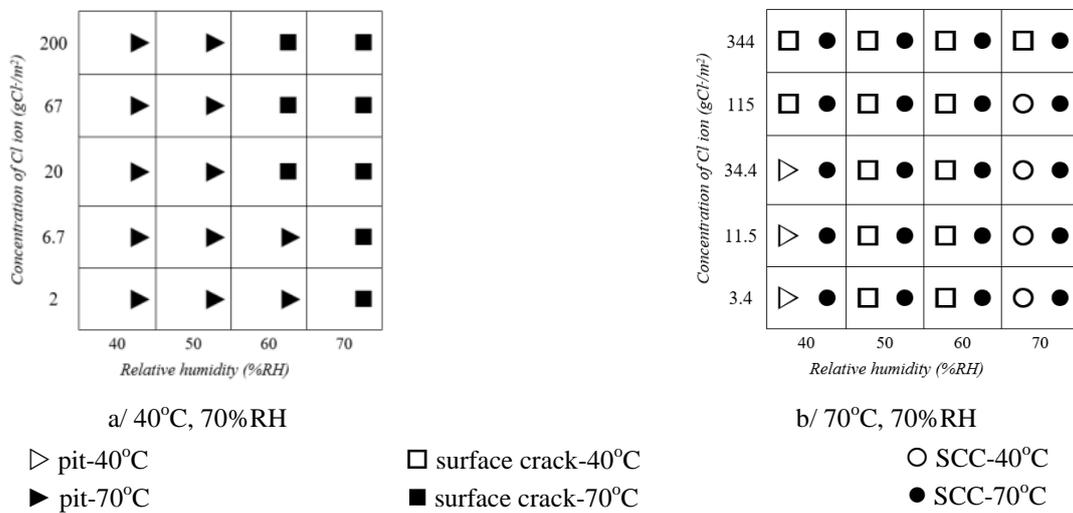
FIGURE 5. The corrosion behavior of the sensitized flat samples with NaCl droplets (a) and MgCl₂ droplets (b)

The results of testing the sensitized flat specimens are given in Fig. 5, which shows higher SCC susceptibility than that of the as-received specimens due to depletion of Cr in the area near the grain boundary

With regard to the sensitized flat samples deposited with MgCl₂, the pits and shallow SCC crack were observed more severely than those dropped with NaCl, which is indicated by the larger SCC cracking size (Fig. 5.b). The pits and the surface cracks were found right at low temperature (40°C) and low RH (40, 50, and 60%). By means of the increasing temperature and RH, the SCC initiated and the number of crack as well as the crack length becomes greater.

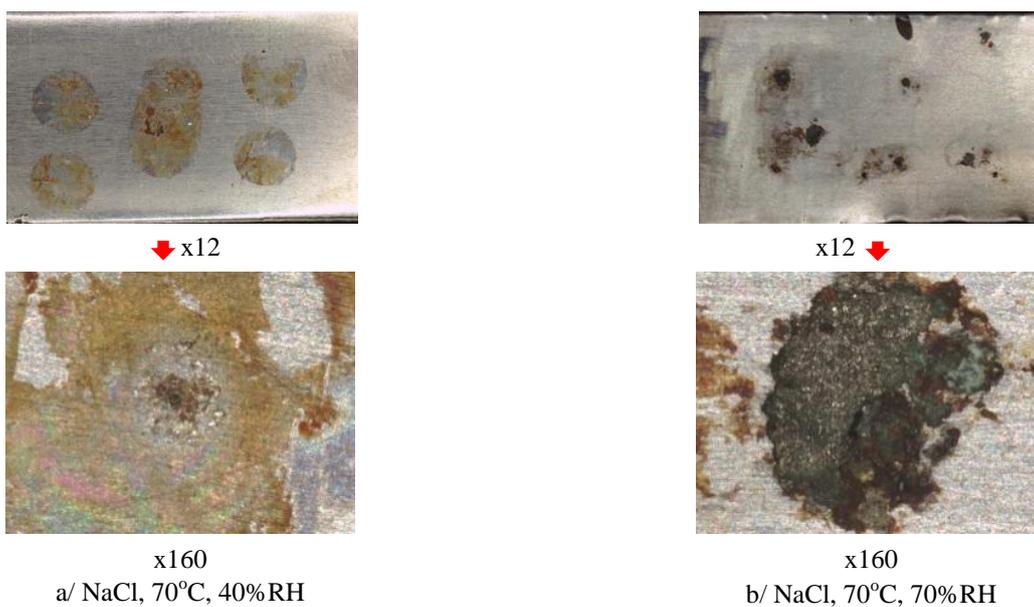
FIGURE 6. The appearance of the sensitized flat samples with saturated solution NaCl droplets

Similar to the as-received samples, the NaCl droplets does not cause SCC of the material at 40°C; however, at the higher temperature (70°C), the pits were formed on the surface of all the samples tested at 40% and 50%RH. At 60%RH, the surface crack was observed on the samples deposited with NaCl of at least 20gCl/m². At 70%RH, the SCC cracks appeared on all samples tested at every NaCl concentration. Therefore, NaCl is easier deliquesced at higher RH, which accelerated the metallic soluble react at the crack tip and promoted the cracks appeared. The increase of temperature and Cl⁻ content also showed the similar promotion as the above.

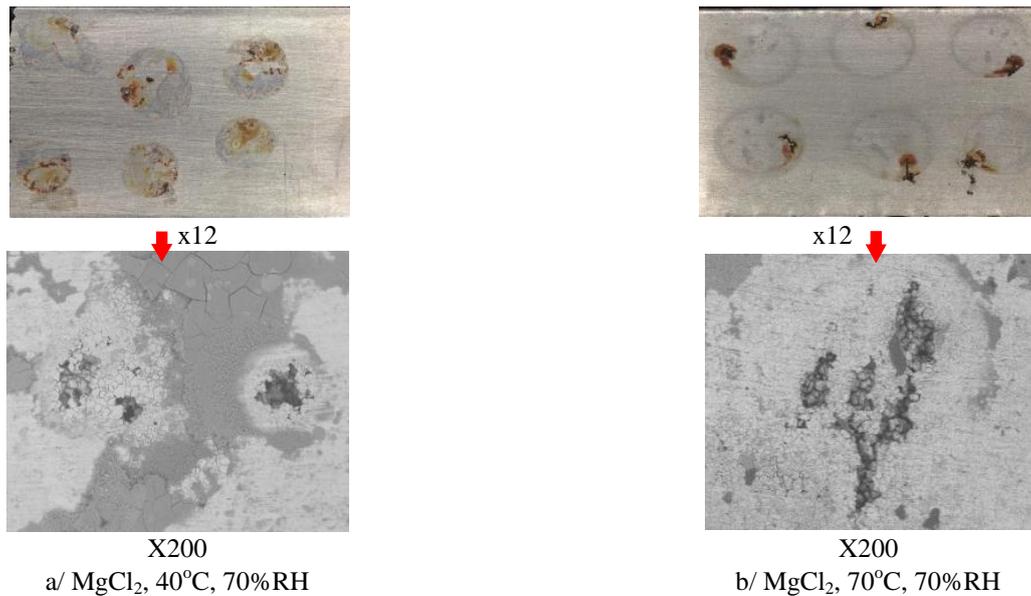
FIGURE 7. The appearance of the sensitized flat samples with saturated solution of MgCl₂ droplets

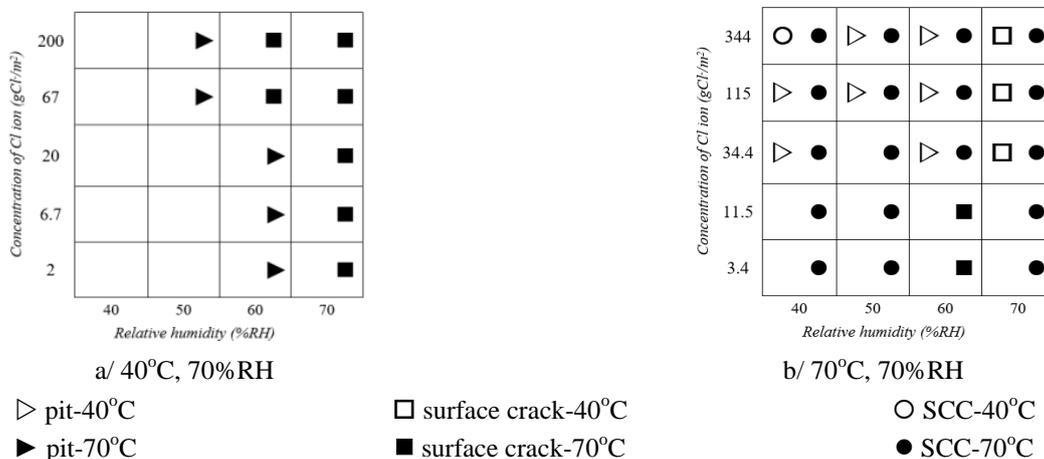
Following the flat sample trials, the U-bend samples were tested in the same conditions with those applied to the flat samples. The corrosion behaviors of the as-received U-bend samples are expressed in Fig. 8.

This suggested that at the low relative humidity, the layer of droplets solution was thinner than the one's at high relative humidity. The oxygen could be easier to attach the surface of material. A combination of ion chloride in the test solution at the high potential on the surface of samples, the SCC initiation was observed. The crack appeared to grow from pit to pit on the specimen surfaces. The SEM confirmed that the crack most often propagated by an inter-granular path.

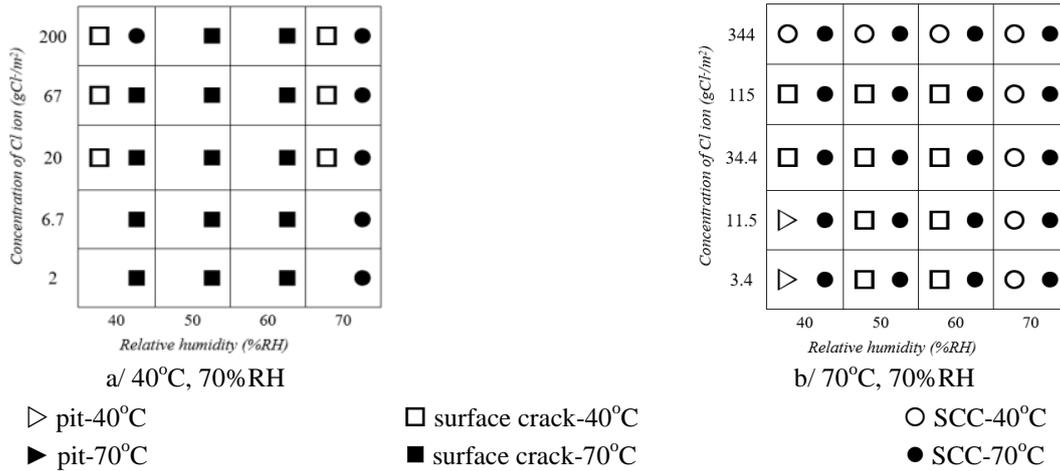
FIGURE 12. The corrosion behavior of the sensitized U-bend samples with NaCl droplets (a) and MgCl₂ droplets (b)

The results of testing the sensitized U-bend samples are shown on Fig. 12. For the specimens dropped with NaCl and tested at 40°C, the surface cracks were found at 40% and 70% RH when the minimum of chloride ion level is ≥ 20 gCl⁻/m².

In the experiments of U-bend specimens with MgCl₂ droplets, the SCC-accelerated was not controlled by the humidity of environment. The main factors which influence SCC were the temperature and concentration of chloride ions (Fig. 12.b).

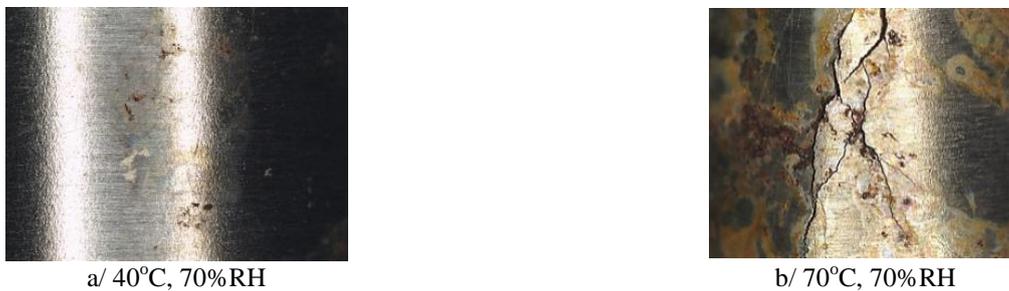
FIGURE 13.The appearance of the sensitized U-bend samples with saturated solution of NaCl droplets (12x)

Under condition of higher temperature (70°C), the surface crack was observed on all the specimens tested at 40, 50 and 60%RH without distinction of concentration of chloride ions. Furthermore, when the RH increased, the SCC crack was found to propagate and the secondary crack was very easily detected (Fig.13).

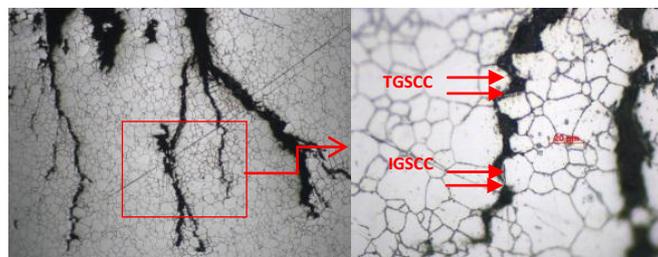
FIGURE 14. Morphology of the crack on U-bend sample 304 (MgCl₂ saturated solution, 40% of RH and 40°C)

pitson the sensitized specimens exposed to $MgCl_2$ at low RH (40% and 50% of RH). The crack often propagated by the inter-granular and trans- granular path (Fig. 14b.).

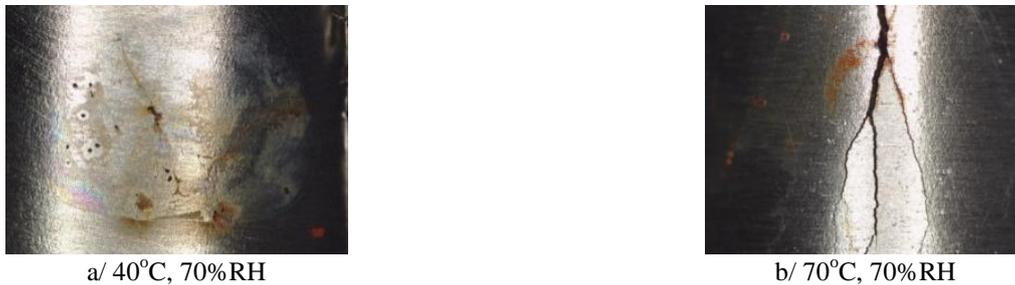
FIGURE 15.The appearance of the sensitized U-bend samples with saturated solution of $MgCl_2$ droplets (12x)

Finally, at $70^\circ C$, the SCC cracks were observed on all of specimens. And the samples were broken clearly due to the high level of relative humidity, and chloride concentration (Fig.15).
